COLONOS LA HACIENDA

2021 ANNUAL PERFORMANCE REPORT

CAL CHAMBERS, TREASURER

2/19/2022

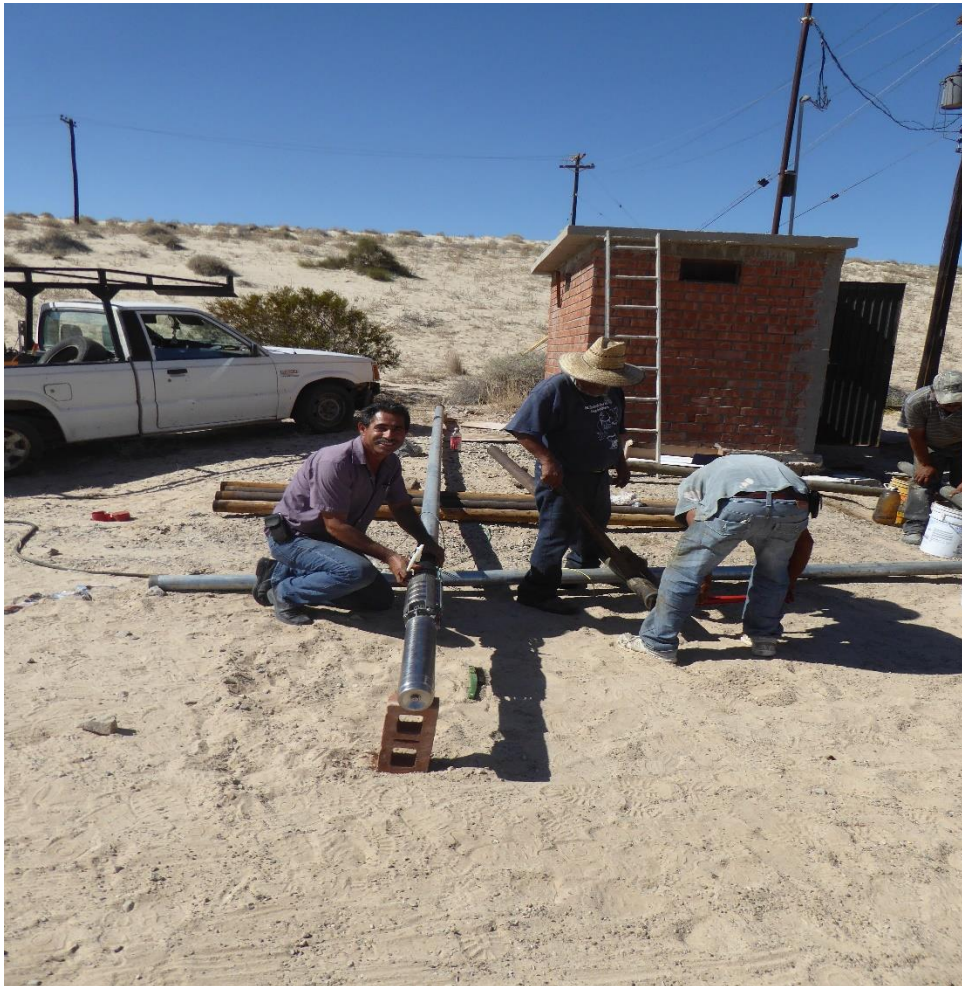
Water Pump Replacement (July 2021)

After 55 months of service the La Hacienda water well pump and old well piping was replaced. Prior to the electrical upgrades (Voltage Regulator, Surge Protector, Low Voltage Sensor) the average life expectancy of the last 5 water pumps was 32 months. The cost of the repair was labor plus new piping for a total cost of \$2,636 as the replacement water pump was on hand.

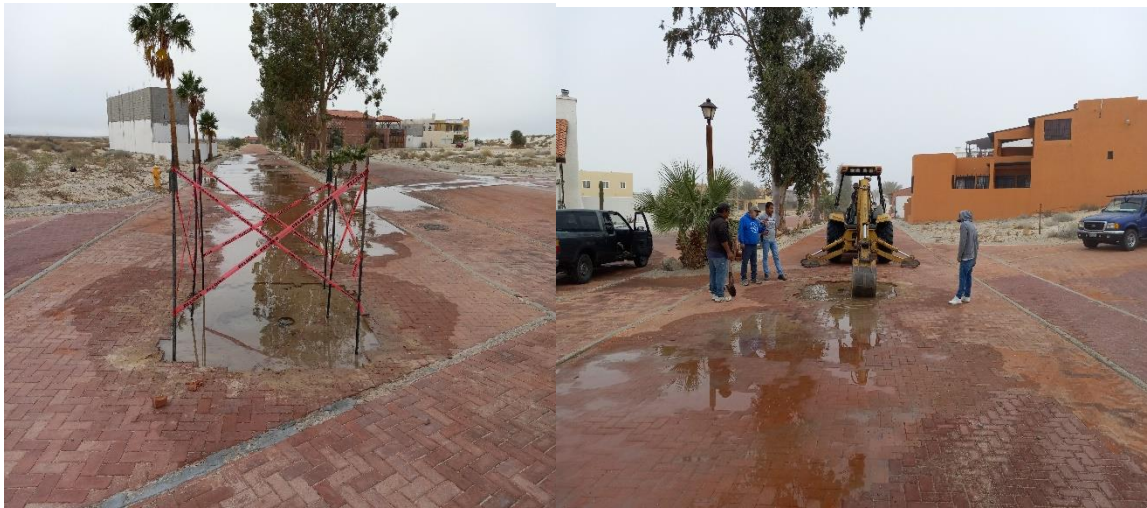
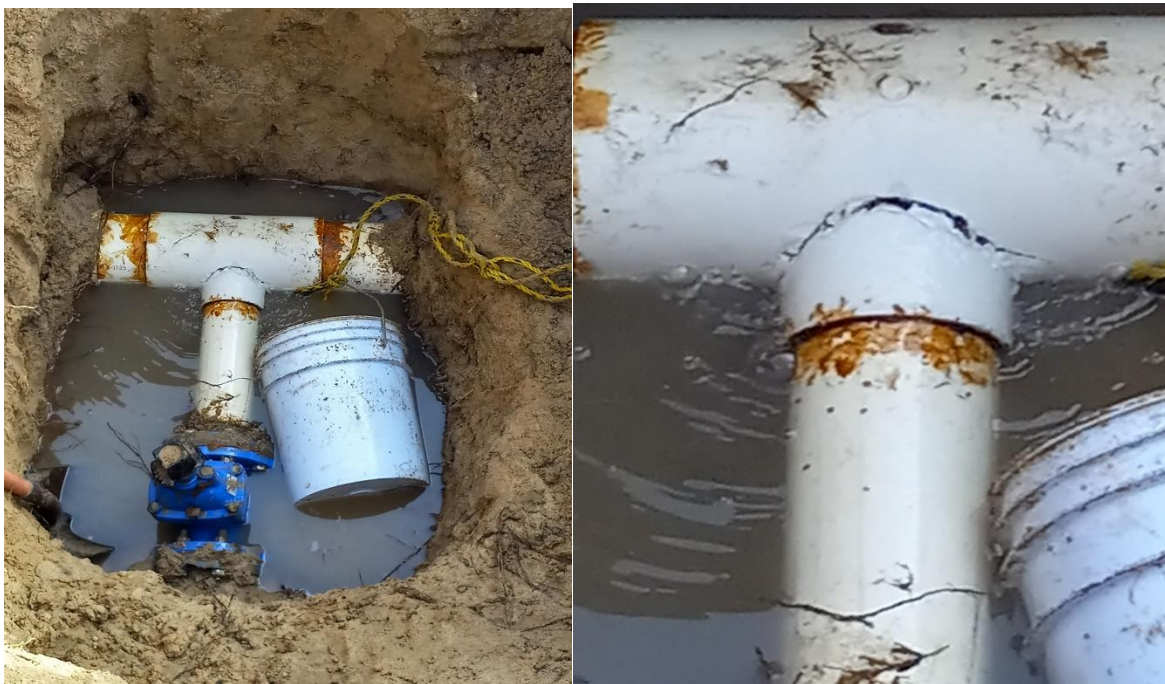
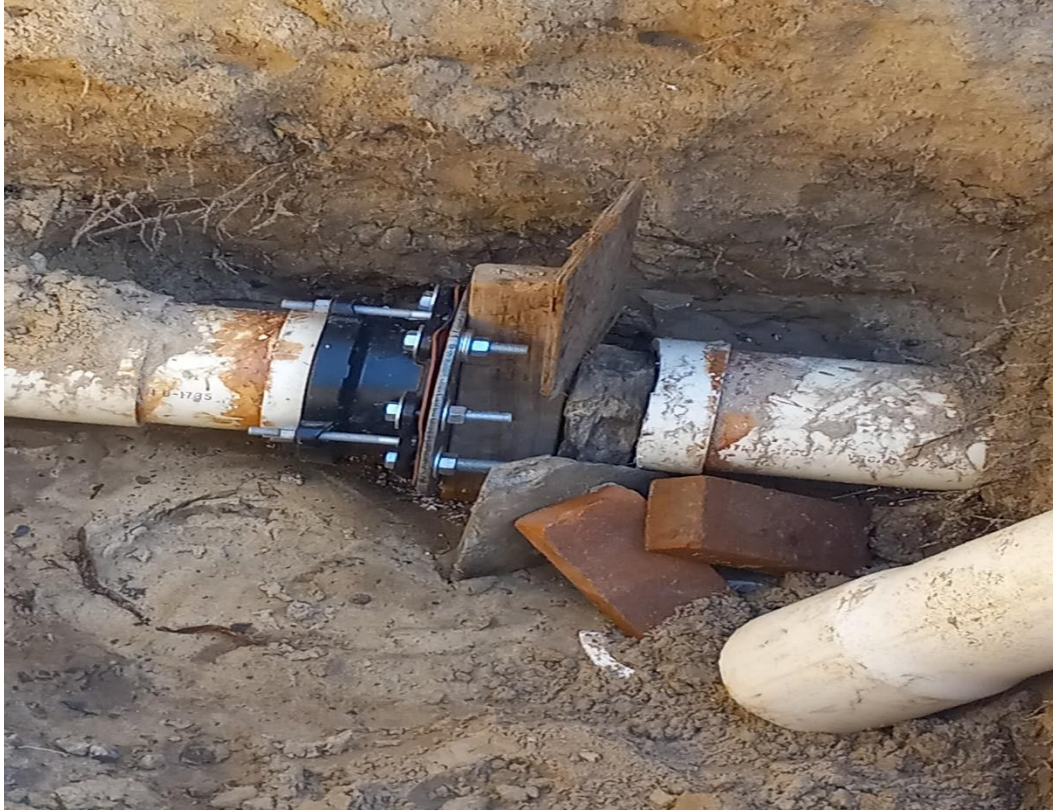
WBS 024 Water Pipe – Though a new water pump had been recently installed water bills for La Hacienda remained high, while water shortages and water reservoir levels remained consistently low. Jose and Alejandro began an exhaustive evaluation of pipes and water valves though out the La Hacienda community. Ultimately the leak was located and it was determined that a trunk line pipe had fractured. The repair was a two-step repair. First the main line was repaired in order to restore water for the greater La Hacienda community. Alejandro traveled to Mexicali for the material required to repair the trunk line to the west side of La Hacienda. The piping was replaced at a cost of \$931 dollars.

Temp repair to return water service to La Hacienda

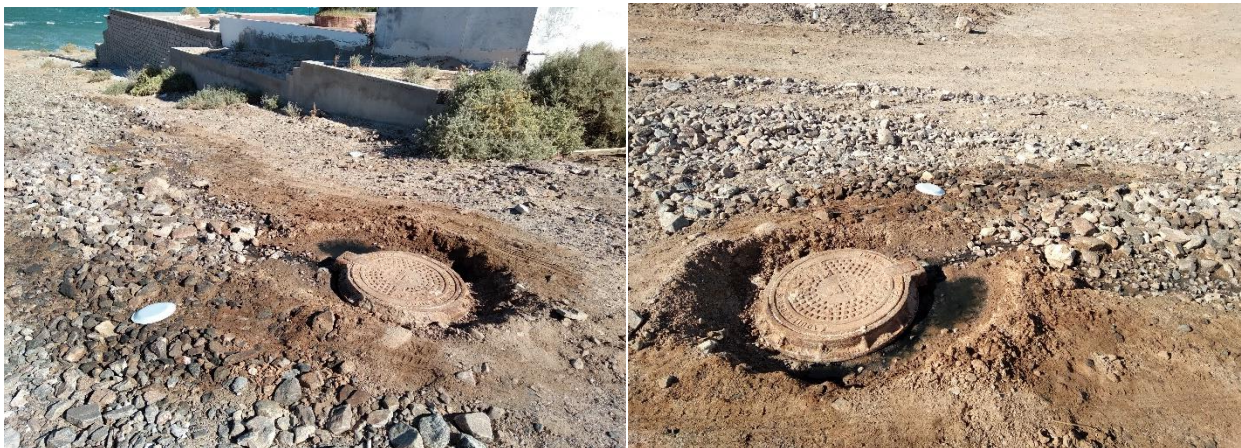
The Sewer Main line had a blockage. The blockage was identified by Jose and repaired by Alejandro at a cost of \$105 dollars.

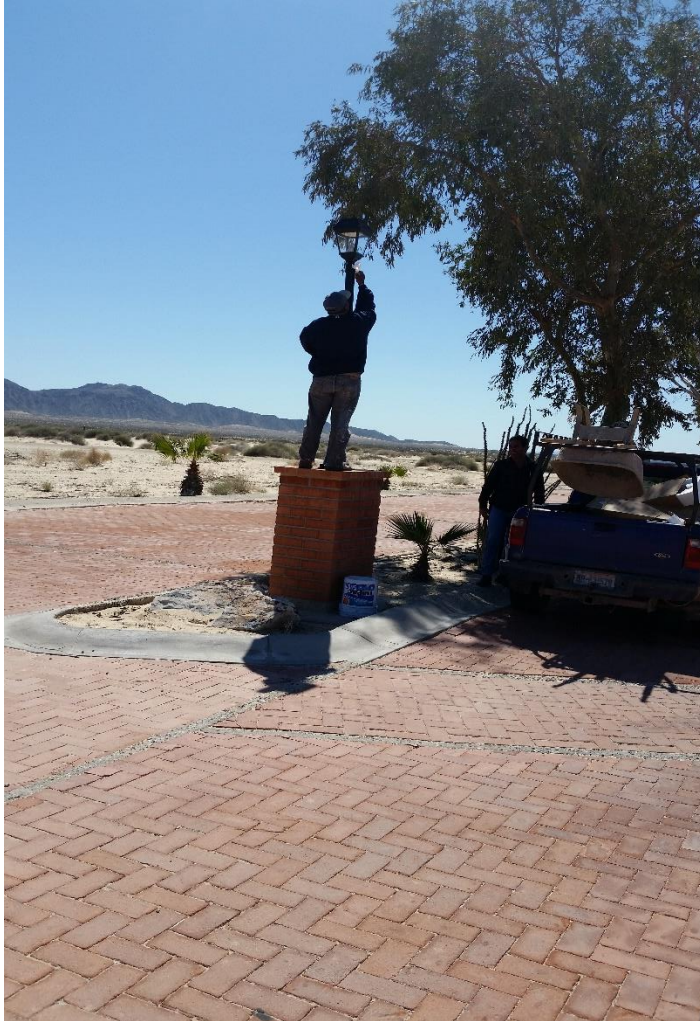
Two solar street lamps were received in December of 2020 and were installed in March of 2021. The 2021 duty, delivery & installation budget planned for this activity was \$350. The actual cost was \$250 for of two street lamps. This completes the street lighting on the main street of La Hacienda. However, other street lighting opportunities exist throughout the La Hacienda Community, e.g. cul-de-sac's without lighting.

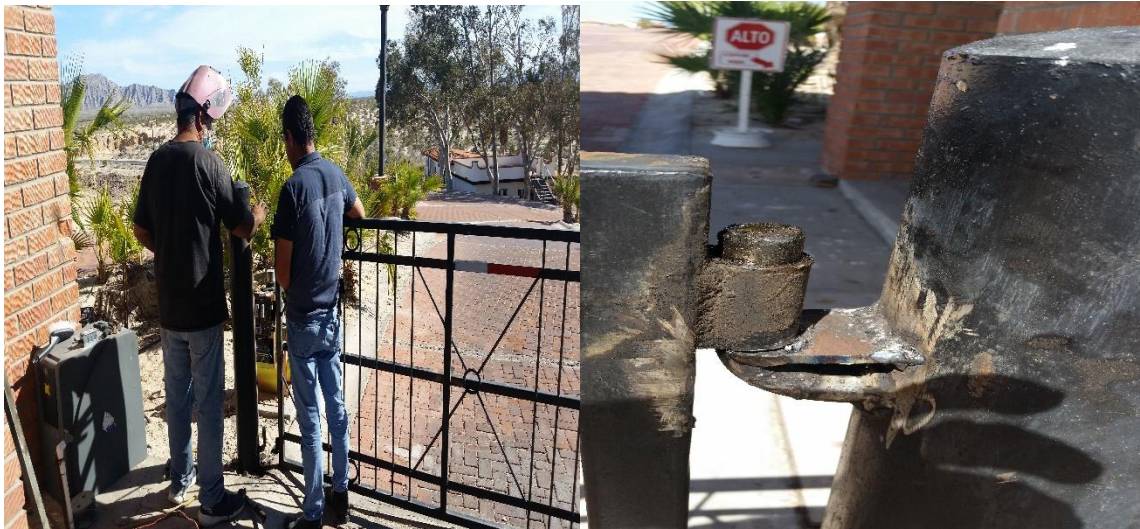
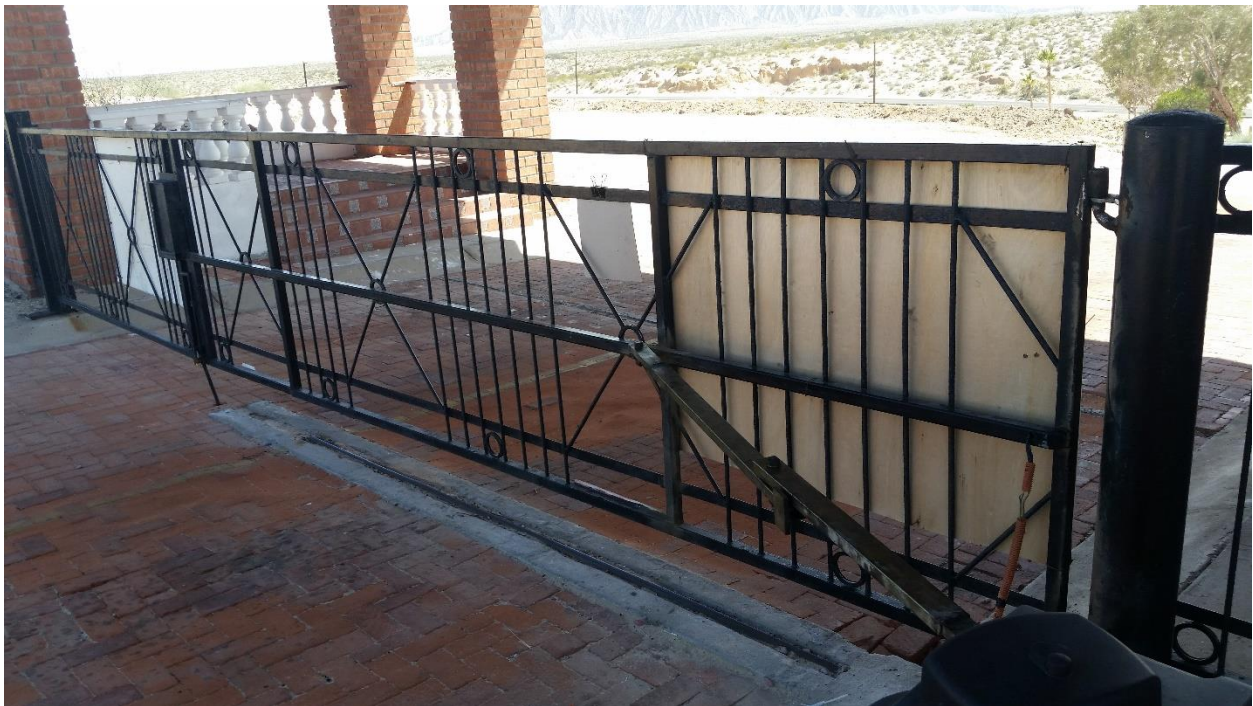
The hinges on the front entrance and exit gates were wearing out and needed to be replaced. Alejandro brought in a custom fabricator for this task. The gates were disassembled, old hinges were removed, new hinges and fasteners were fabricated and welded to the supports and new hinges were fabricated for the gates. The task was budgeted at \$250. The actual cost was \$187 dollars for a \$63 dollar underrun.

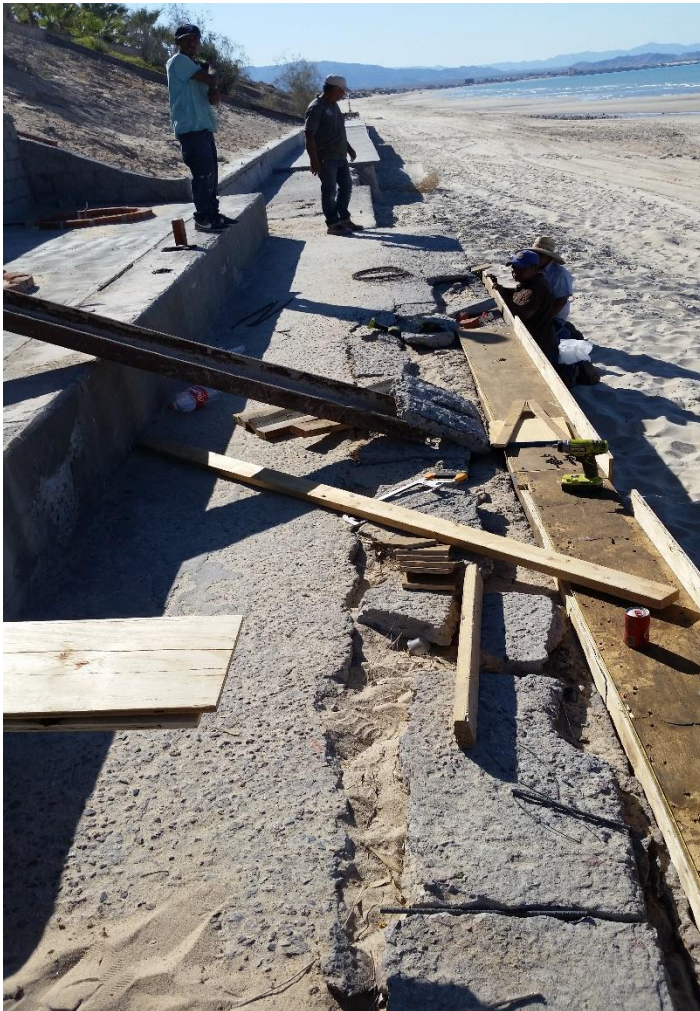
As part of the continued ongoing maintenance of the sea wall a portion of the Sea Wall cap was replaced. A budget of \$1,000 dollars was planned for this task. The actual cost was \$768 dollars for a \$232 dollar underrun. Of note, this activity was done concurrently with the stair replacement.

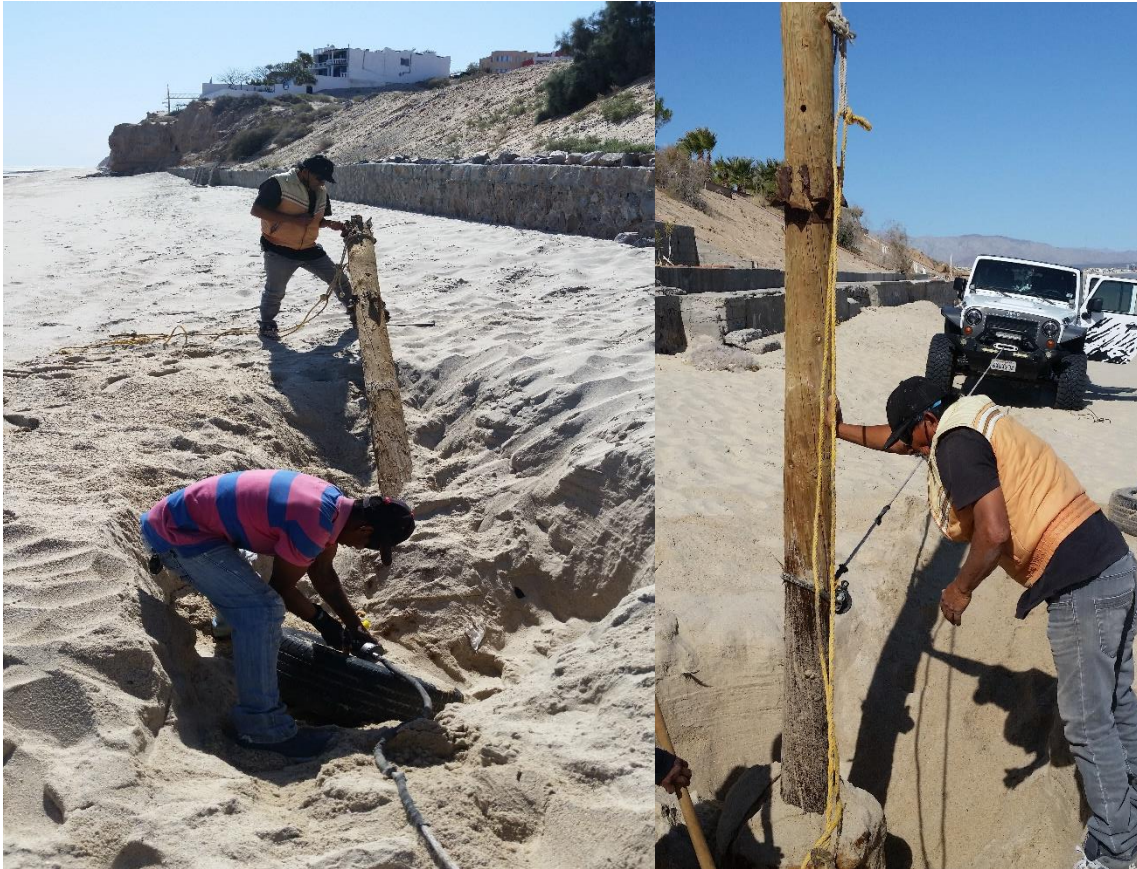
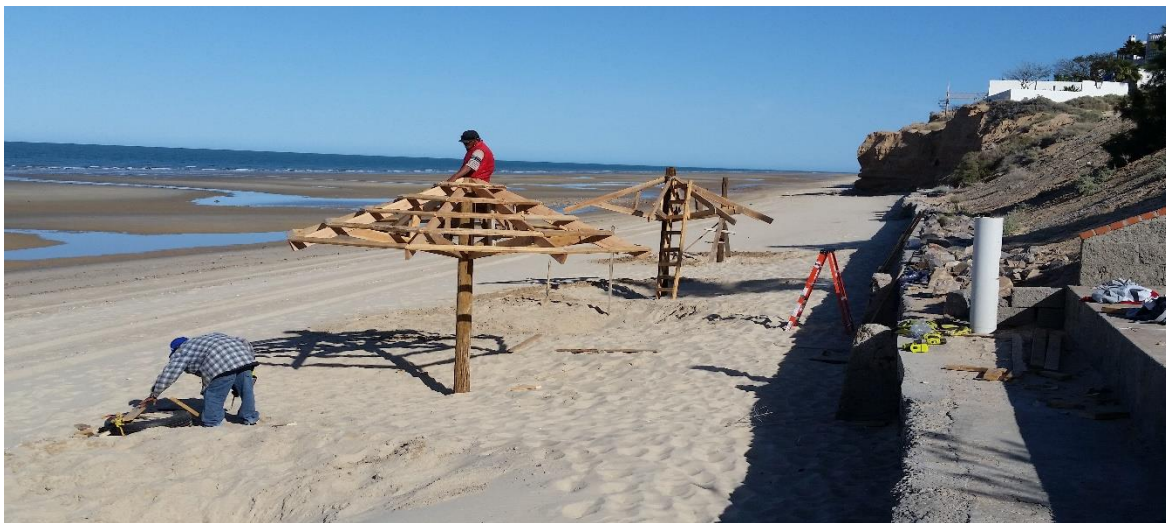
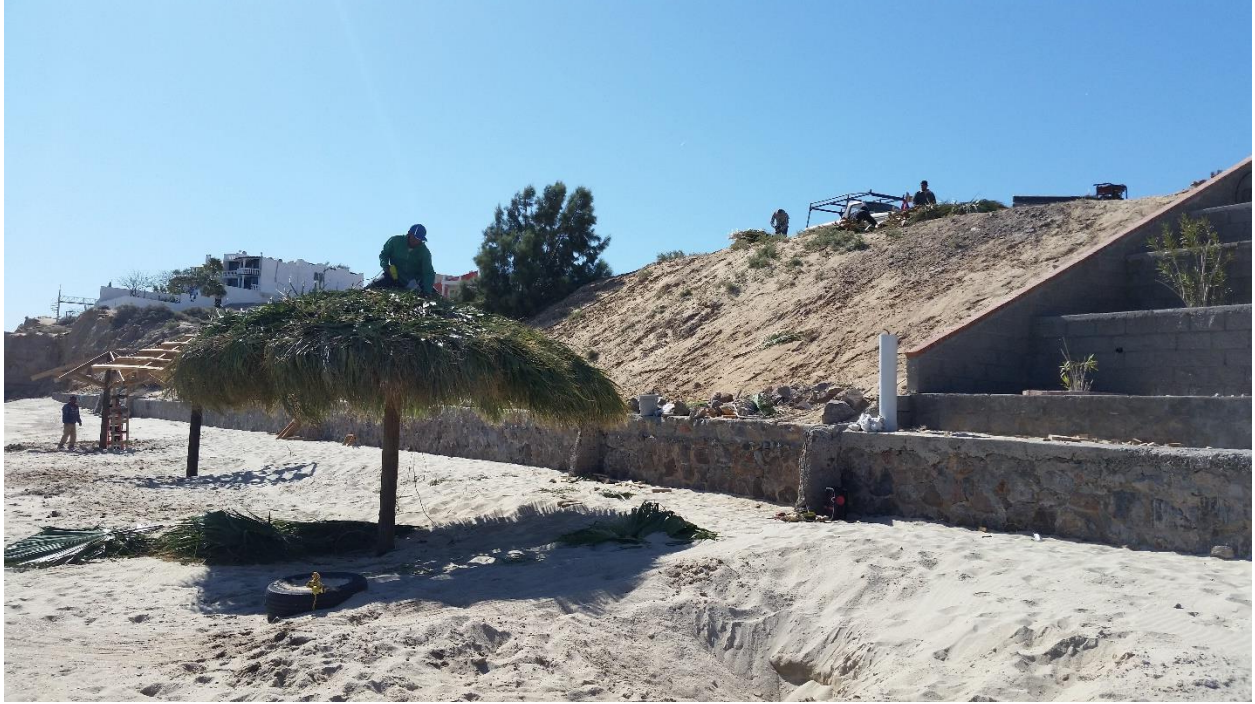
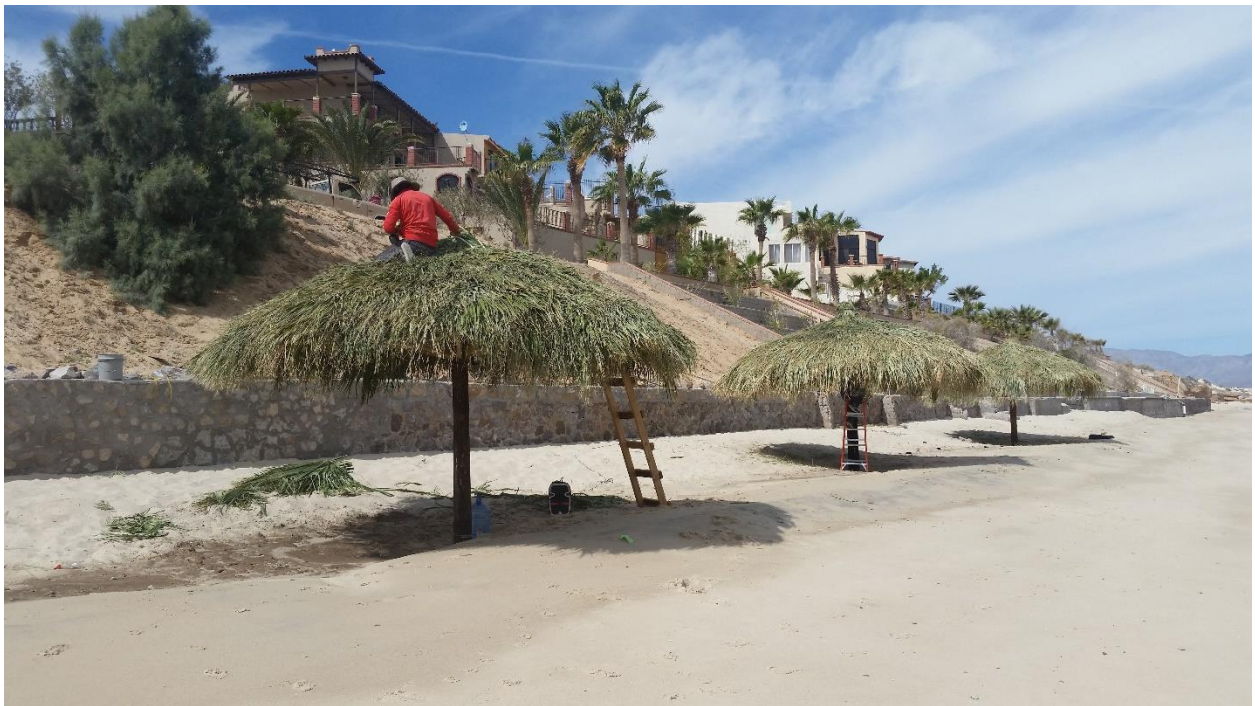
The replacement of the original three Palapas lost has been anticipated since their loss in October of 2019. A budget of \$2,430 dollars was planned for this task. The actual cost was \$2,558 dollars for a \$128 dollar overrun.

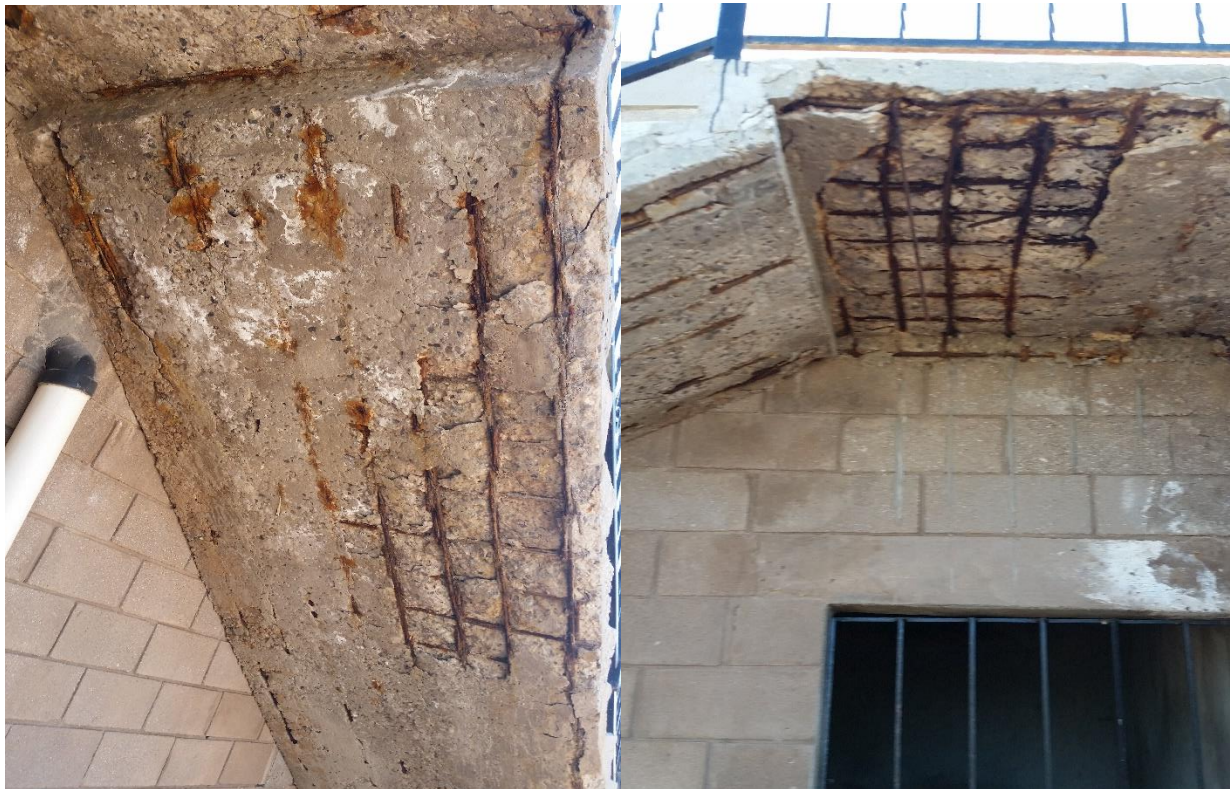
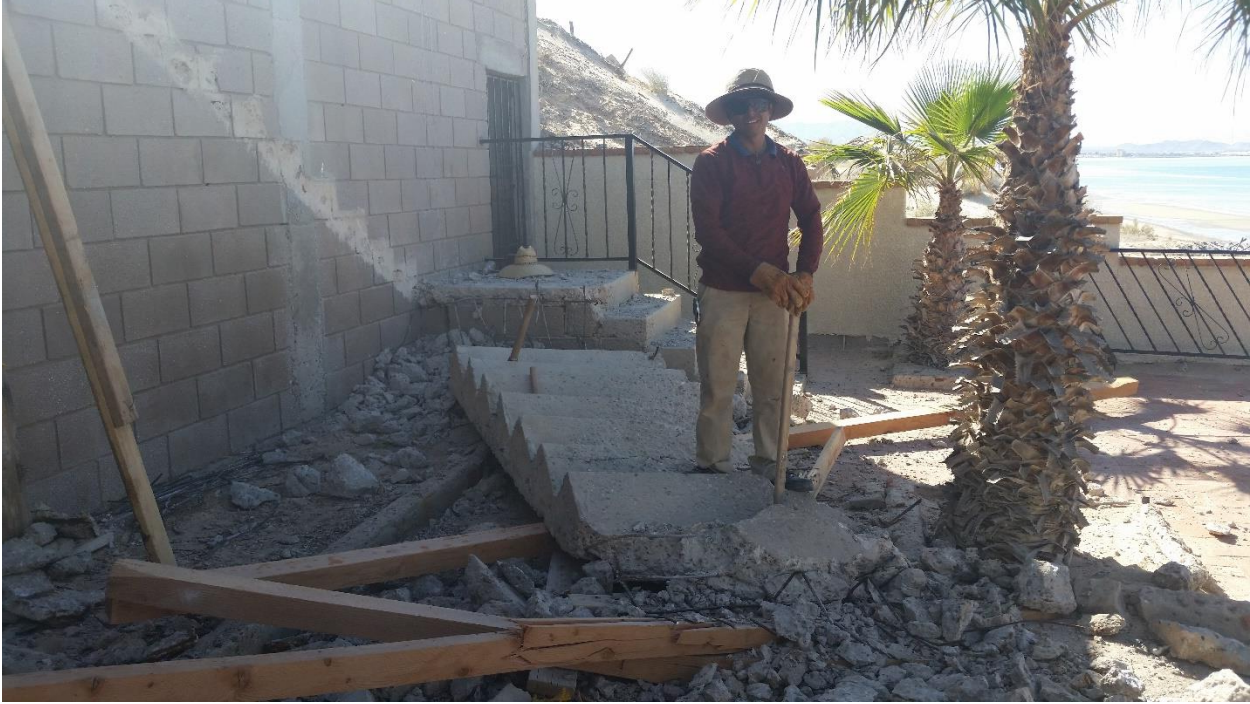
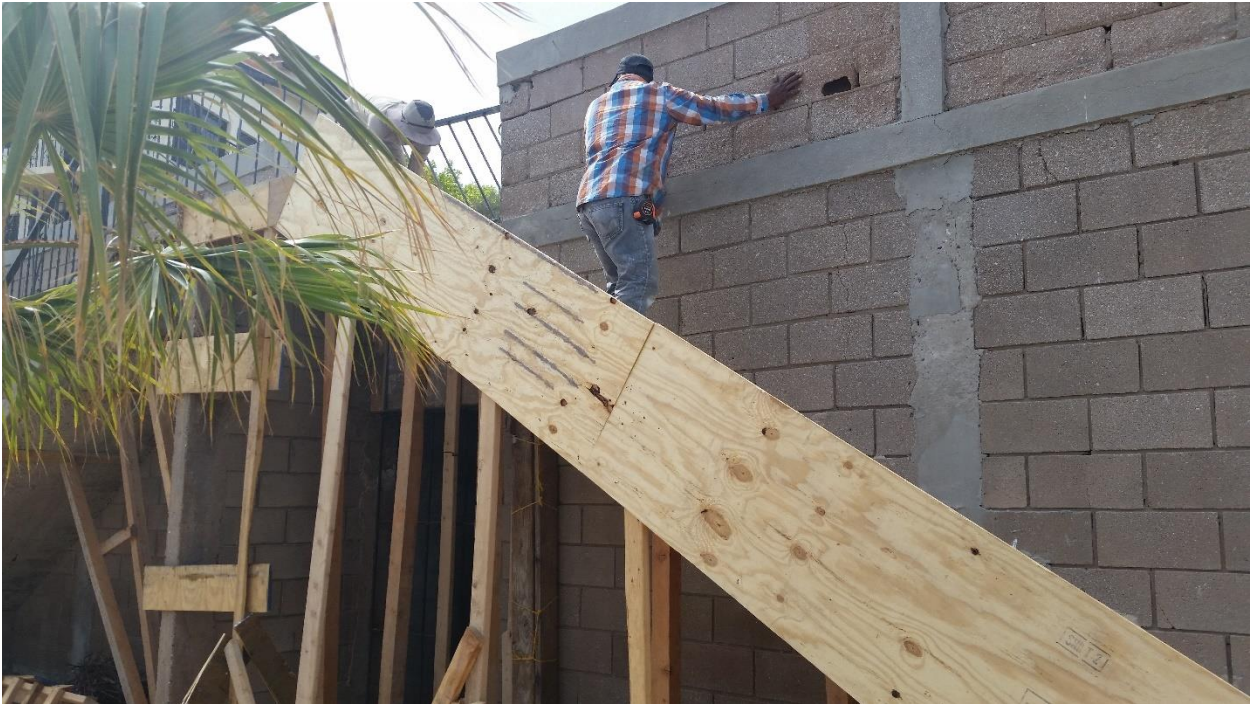
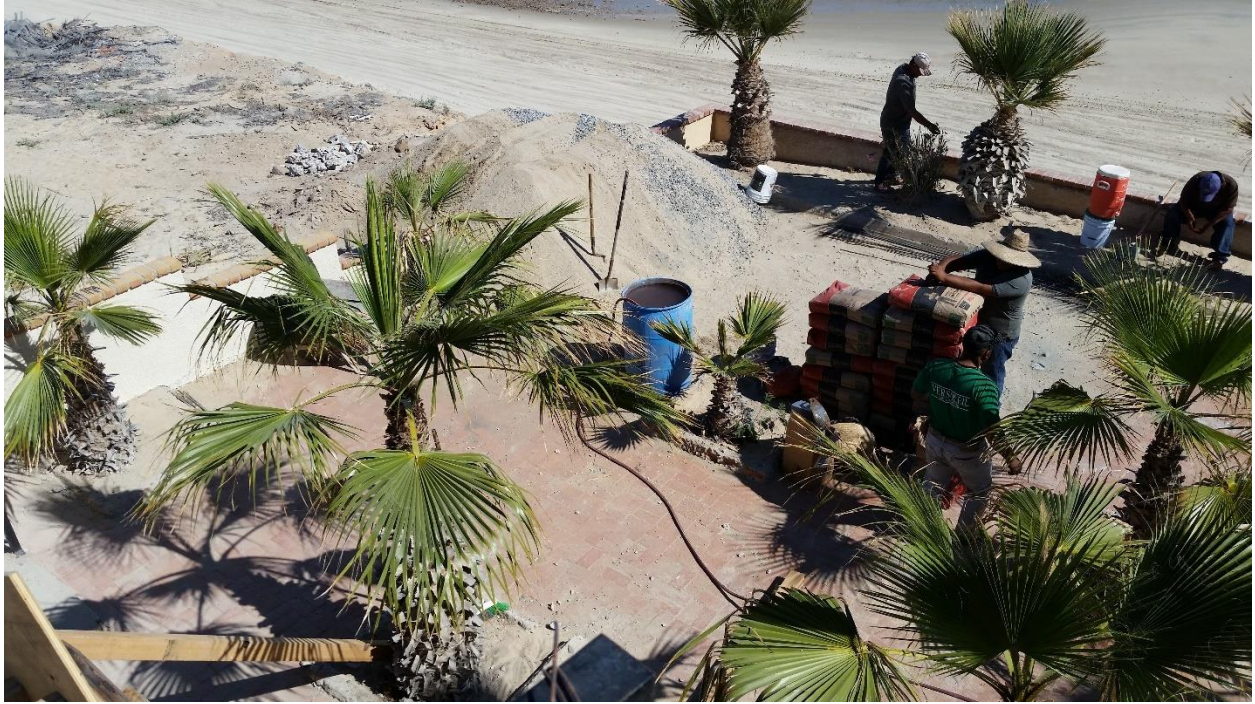
The 2021 budget included an estimated \$1,500 dollars for repair of the original stairs from the terrace to the Malecon. Upon further examination it was determined that the stairs needed to be demolished and replaced with new construction, at a cost of \$2,401 an overrun of \$901 dollars. Of note, during the demolition process I observed the stairs collapsed on their own accord.

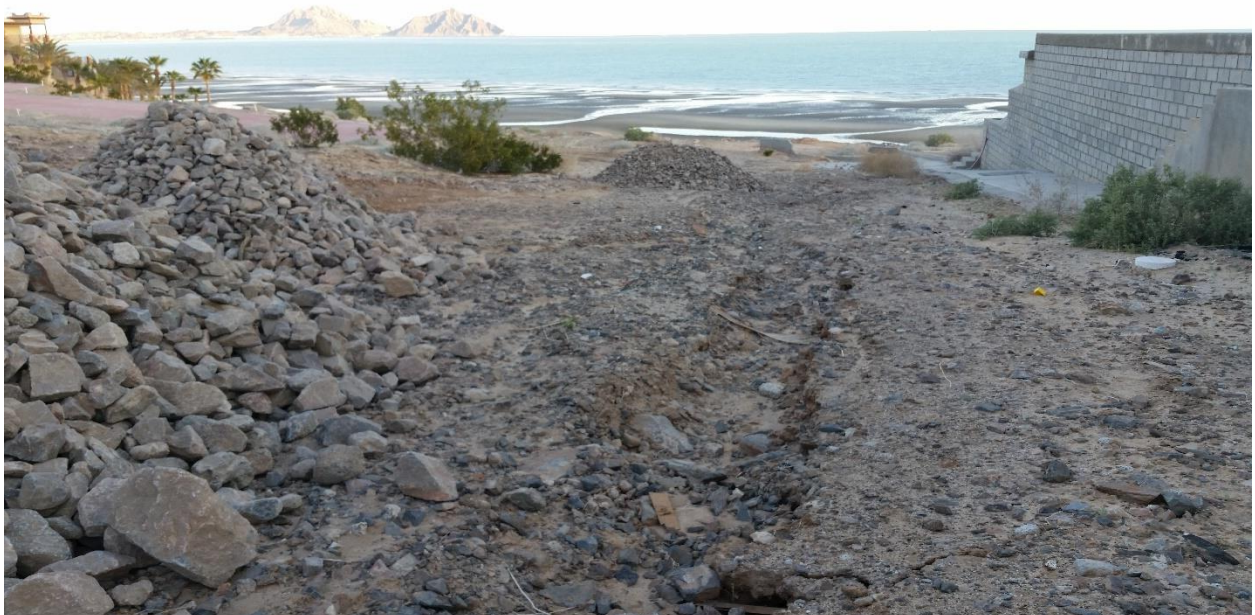
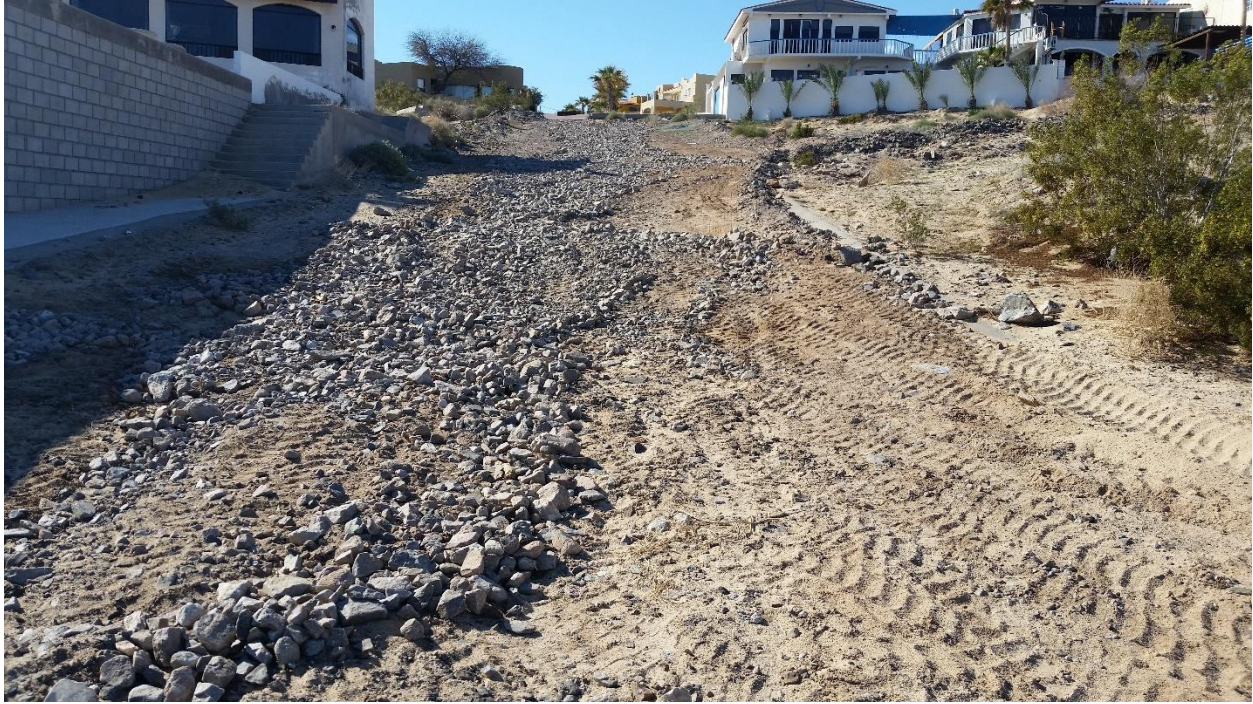
Erosion of the access road from the center of La Hacienda to the Malecon continued to be a problem. The dirt that was previously added simply washes/blows away over time. Three truckloads of large gravel were brought in to fill in the gullies caused by water runoff. A budget of \$1,000 dollars was planned for this task. The actual cost incurred was \$966 dollars for a \$34 dollar underrun.

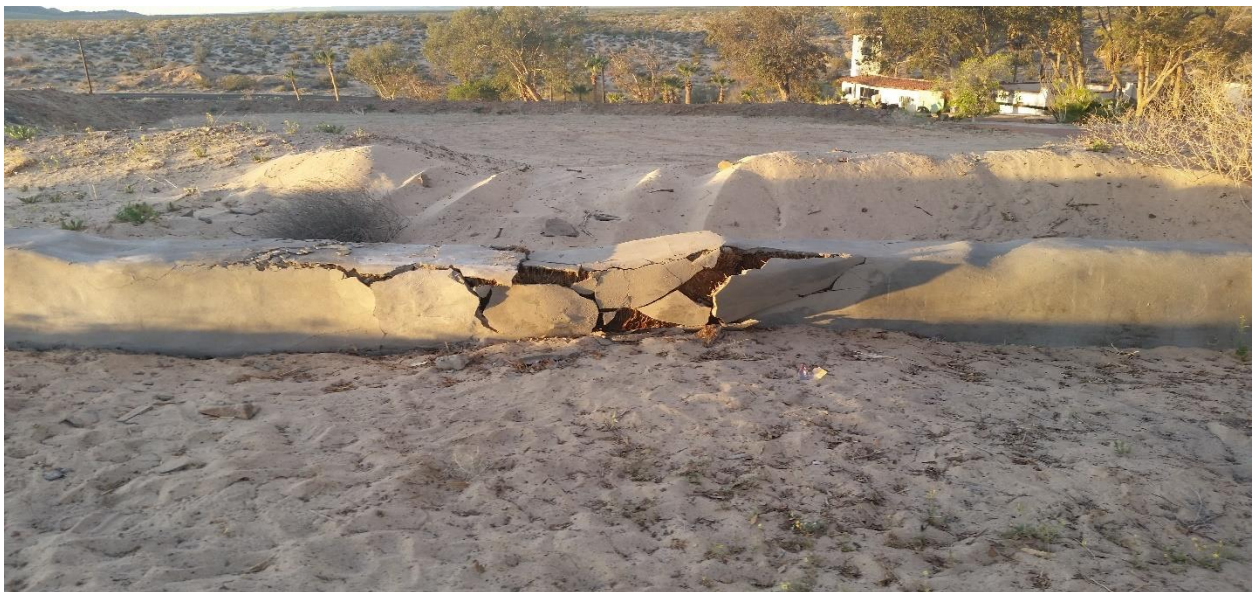
A budget of \$400 dollars for additional berms was planned at the Entrance to La Hacienda. The actual cost for berms was \$341 dollars for a \$59 dollar underrun. Back story; every spring in preparation for Spring Break we build/repair the berms on the west side of the entrance gate.
